Manhole Inspection Summary

Manhole # S15KK1016MH

Insp Date: **6/18/07 10:27 AM**

Location Address: **4400 PACKARD RD**

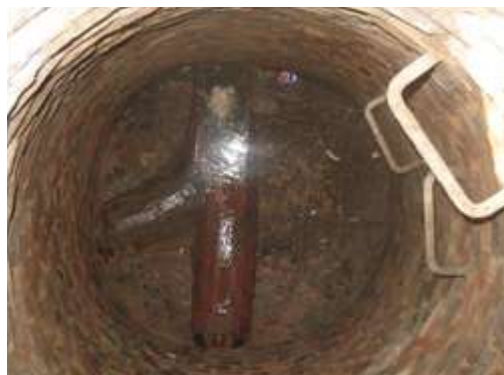
Top View

Evidence of surcharge - Bench debris.

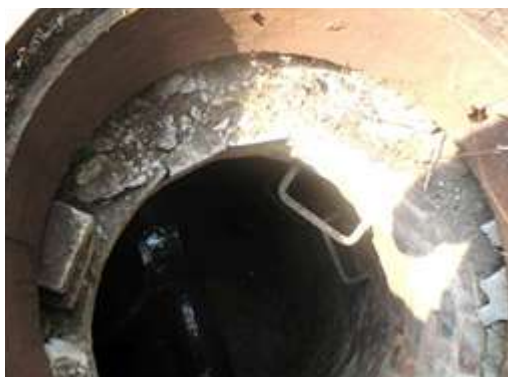
Defect

Frame leaks. Frame offset. Adjustment deterioration, loose brick and infiltration.

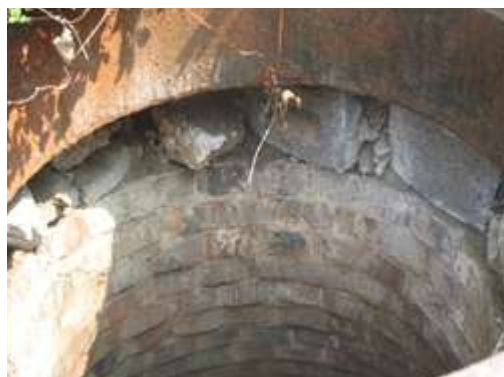
Defect

Frame leaks. Adjustment deterioration, loose brick and infiltration.

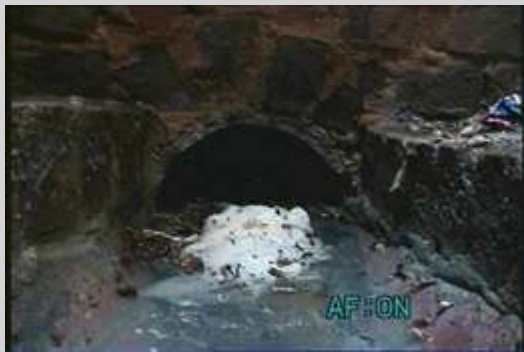
8 in. Circular Gravity Sewer Pipe Out @ 12 O'Clock

Deposits: ☐ None ☒ **Mud** ☐ Sludge ☒ **Debris** ☐ Grease

Silt Depth: **3** (in.) Deposits Extent: **Medium**

Infiltration: **Evidence** Pipe Seal Cond: **Cracked**

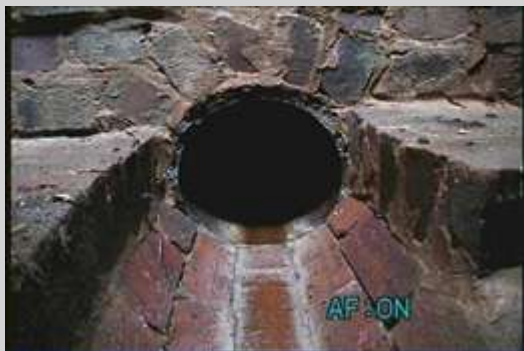
8 in. Circular Gravity Sewer Pipe In @ 6 O'Clock

Channel deterioration.

Infiltration: **Evidence** Pipe Seal Cond: **Unknown**

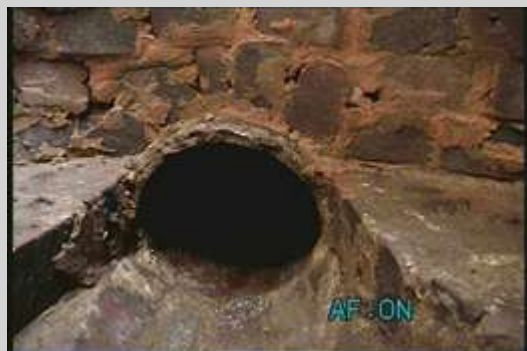
Pipe In @ 8 O'Clock

Barrel deterioration and infiltration.
